**Township of Cavan Monaghan**

**Road Needs Study Report – 2024**

**D.M. Wills Project No. 24-4911**

**July 2024**

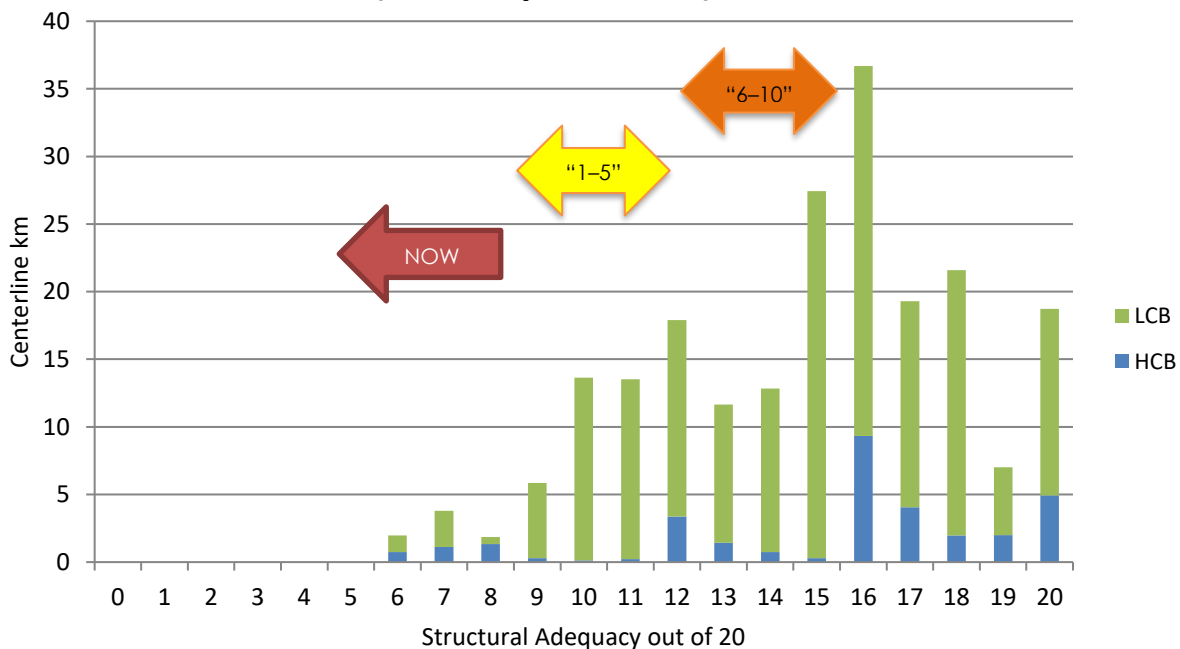
### Structural Adequacy Distribution (Hard Top Surfaces)

A review of the structural adequacy distribution of the Township's hard top roads identifies a group of roads, 130.8 km, that are in very good condition (structural adequacy of 15 and over), and with regular resurfacing and preservative maintenance, should not require reconstruction in the next 10 years. Another cohort of roads, approximately 42.4 km, are in average condition (Structural Adequacy from 12 to 14). Some of these roads may continue to perform well, but without timely resurfacing and preventative maintenance, many of them are expected to become NOW or 1–5 year needs. The remaining 40.6 km of hard top road network is well distributed over the very poor to poor range (structural adequacy from 1 to 11). Most of these roads will require reconstruction over the next 5 years to fully repair them.

It is therefore recommended that, while the Township endeavors to repair these poor roads as part of its 10-year capital plan, every reasonable effort is made, through preservation management, to prevent the current cohort of fair to very good roads (130.8 km) from becoming capital reconstruction needs themselves.
